# Hydraulic Analysis of Submergence Damage by Typhoon 9918

Keisuke SAITO\* and Susumu OGAWA\*\*

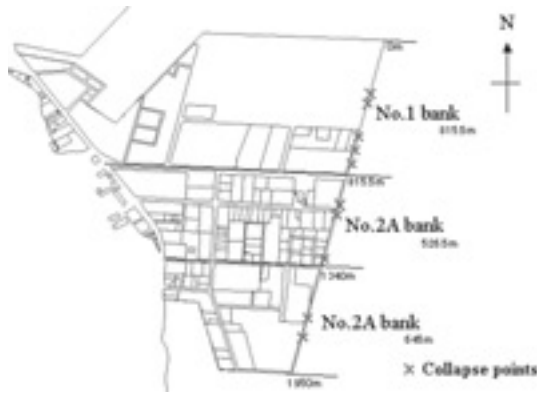
Figure 2 New Moji Port, south area

South New Moji area (about 180.6 ha), Moji district, Kita-kyushu city, Fukuoka prefecture, was the target in this study (Figure 2). This district was reclaimed land with two constructed banks. A bank of the north side (No. 1) has 814-m extension, while a bank of the south side (No. 2) has 1,171-m extension (Total extension becomes 1,985m). However, these banks were destroyed at 10 points by the wave force of the typhoon invasion (Takahashi *et al.*, 2000). A large amount of seawater invaded by wave overtopping and influence of bank collapse. Therefore, this area suffered the serious inundation damage. The bank No. 2 was divided into two (A and B) for convenience in this study (Figure 2). Especially, the bank No. 2A that received terrible damage was inspected. All the heights were described with a value of the chart datum level (C. D. L) in the following sections and figures.

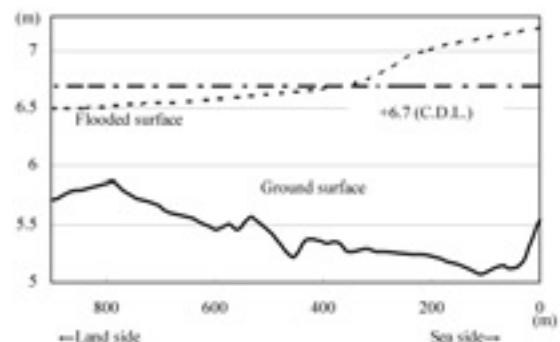
Figure 5 Flooded water and ground elevations

An average submergence surface was obtained from the heights of the ground and submergence (Figures 5 and 6). However, it did not form a smooth surface by influence of surge fluctuations and a spatial distribution of the measurement points. The average submergence surface was estimated as +6.7 m. The result was shown in Table 4. It was found out that most of the areas were flooded. In particular, the damage through East and West roads were huge. The result of ground elevation surveying showed the tendency that roads sank lower than the circumstance. In the

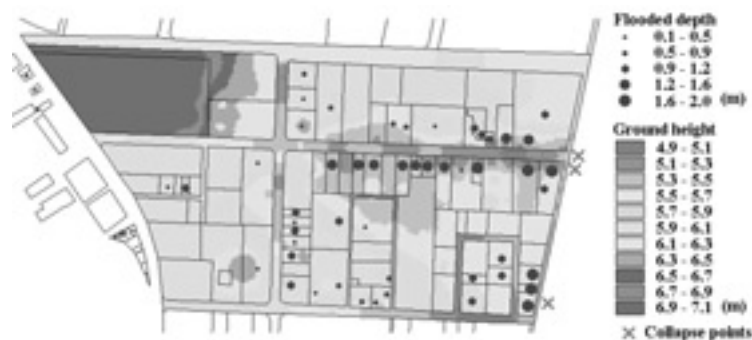
Figure 6 Ground elevation map

reclaimed land, seaward is lower than land side for drainage. However, some points became the topography like a hollow by local settlement. Drainages for rainwater existed in the target area. However, there were no water gate or no countercurrent prevention functions. Accordingly the rainwater drainage in the target area was in bad condition. Most rainwater concentrated into the target area. It was shown that the

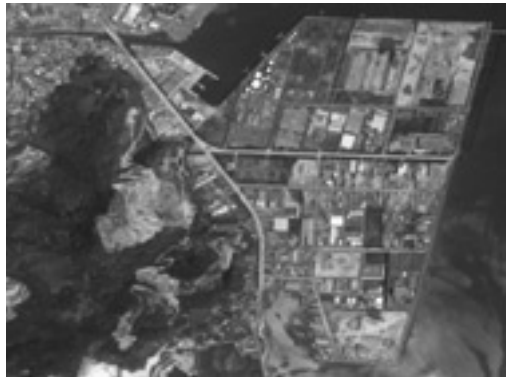
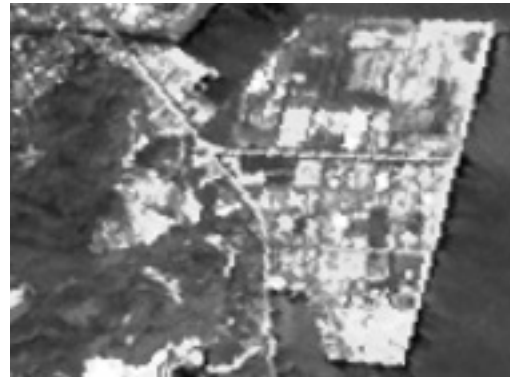
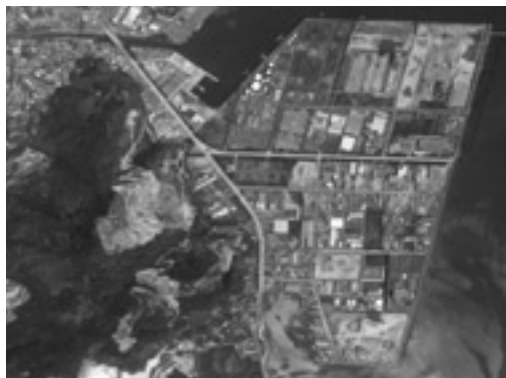
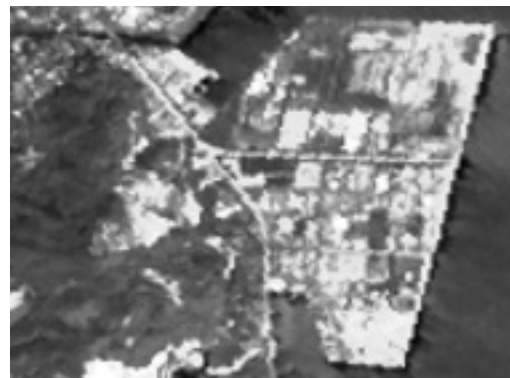
(a) Aerial photograph

(b) VNIR of Terra/Aster (Bands 1, 2, and 3N)

(c) SWIR of Terra/Aster (Bands 4, 5, and 9)

(d) TIR of Terra/Aster (Band 13)

Figure 8 Various images of the study area
